FREE Studio Plus

Release Notes

9MA10300.07

11/2023 v1.6.0

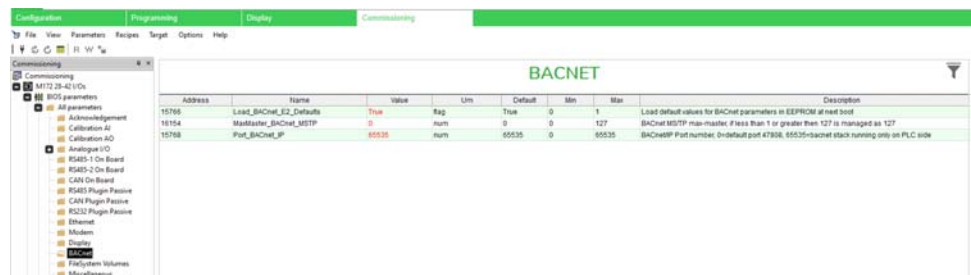
Introduced new BIOS parameters 16154 MaxMaster_BACnet_MSTP to enable BACnet protocol to modify by parameter max-master property. If 16154 value is 0 or greater than 127 then max-master is forced to 127, otherwise max-master is the value of 16154 parameter

Below the new parameter in BIOS parameters\All parameters\BACnet folder

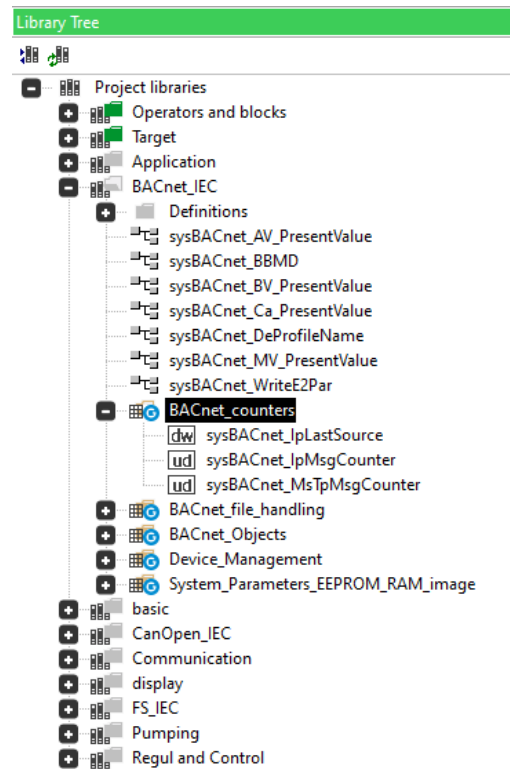
Below the new Target Data Blocks folder in BACnet_counters

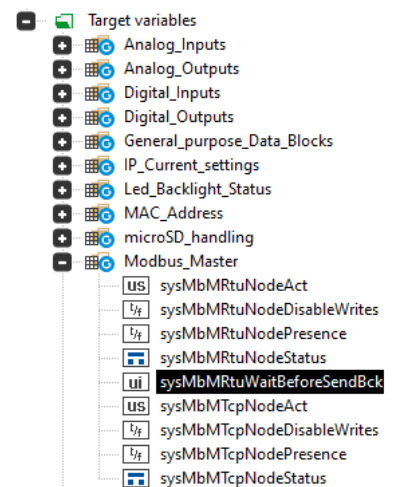
Description:

Wait before send time used by functions sysMbMRTU_FCxx(), value is lower limited to 50 [ms]
